February 16, 2005

Trikke T12 Roadster Recall Notification

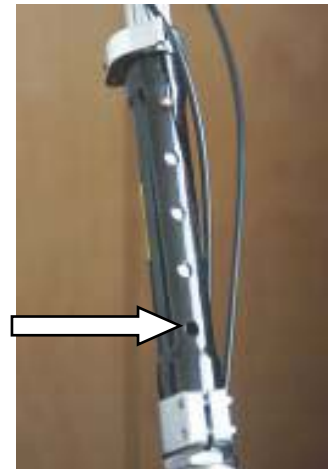
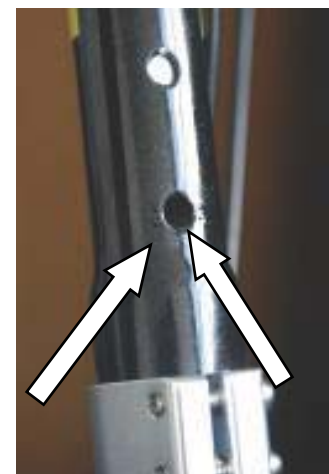
Since the release of the T12 Roadster in Fall of 2004 it has been brought to our attention by owners that there could be a potential problem with the strength of the steering tube riser. This part is identified as the 10 inch painted tube below the handlebar quick adjustment collar as seen in the photo to the right.

This problem is most apparent with tall and aggressive riders who regularly climb hills. When the handlebars are raised into the highest position for tall riders, note that the bottom hole is exposed (see arrow in photo to the right). This exposed hole can develop stress cracks which are evident upon inspection. The first signs of this wear can be seen as stress cracks in the paint. We are concerned that the tube might fail under stress.

Please inspect your T12 to insure that you are not experiencing this problem. If you do find stress cracks, do not ride the T12. Please email us directly at infotrikke12@trikke-europe.com or phone: +31 70 335 6979 for more information related to this recall.

Trikke Tech is in the process of manufacturing an improved replacement part for your T12. We will contact you and ship them immediately with installation instructions.

If you do not see any unusual wear on your T12 riser tube, it is safe to continue casual riding, but we urge you to ride conservatively and to re-inspect the tube periodically on each ride. We want you to be able to ride, but precautionary measures should be taken until the part has been properly replaced. Do not ride aggressively or at high speed --- especially on hills. As another cautionary measure, please do not ride with your handlebar in the highest position.
